MEMOIRS OF THE
ARCHAEOLOGICAL SURVEY OF INDIA
NO. 91

ANGKOR VAT

INDIA'S CONTRIBUTION IN CONSERVATION

1986-1993

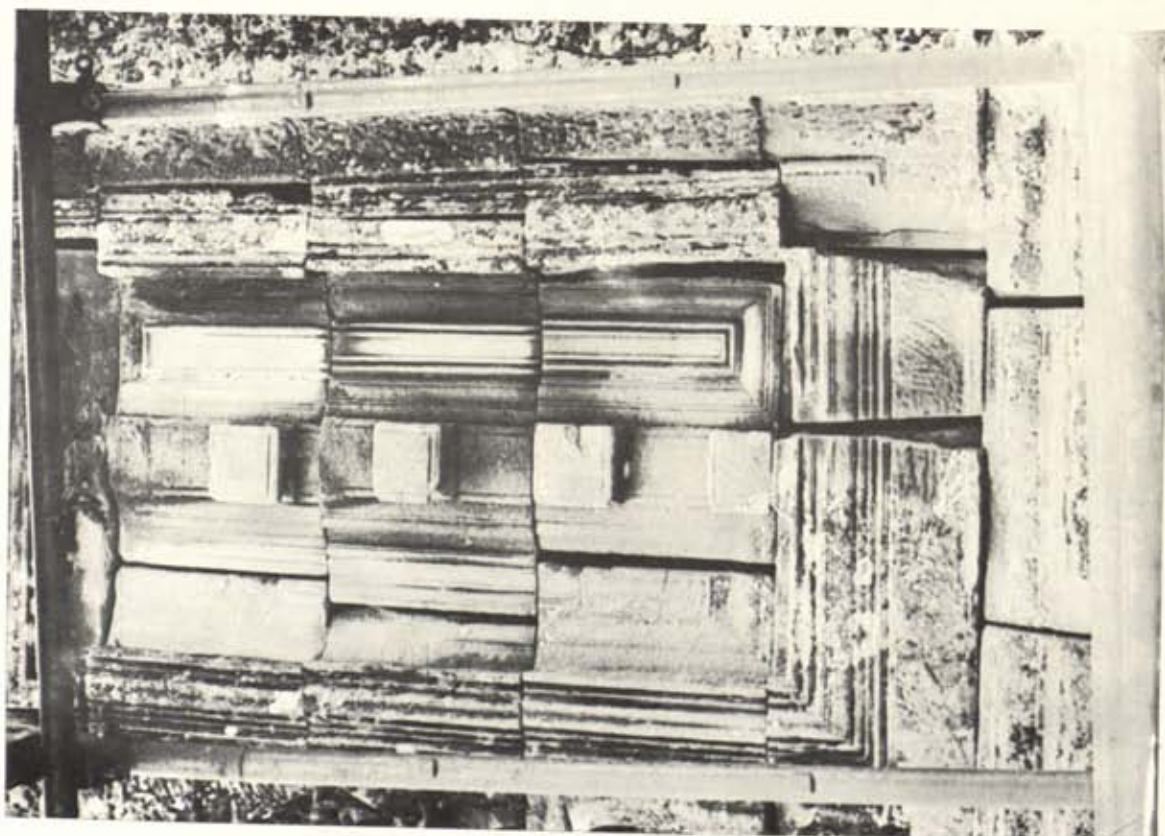
A

Northern Library between Third and Fourth Enclosures : false window, A, before and B, after conservation

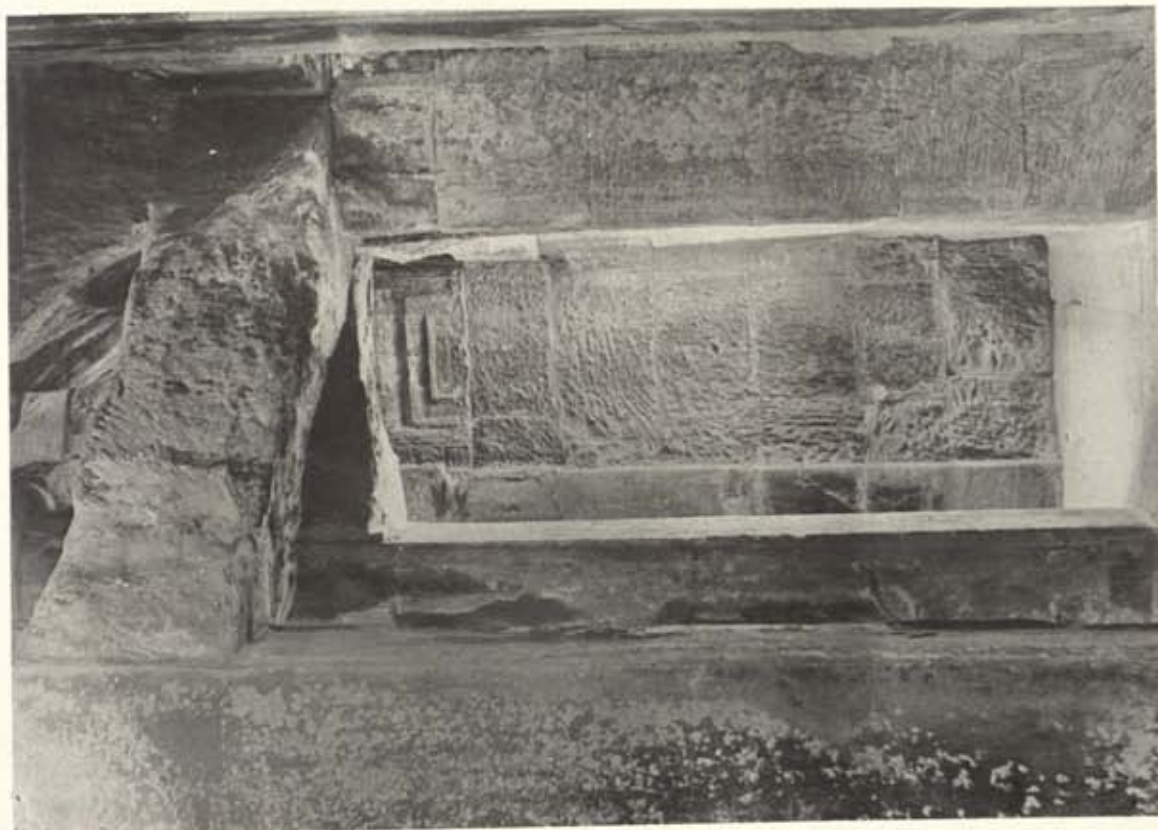
B

Northern Library between Third and Fourth Enclosures : tie-beam of the verandah, A, before and B, after conservation

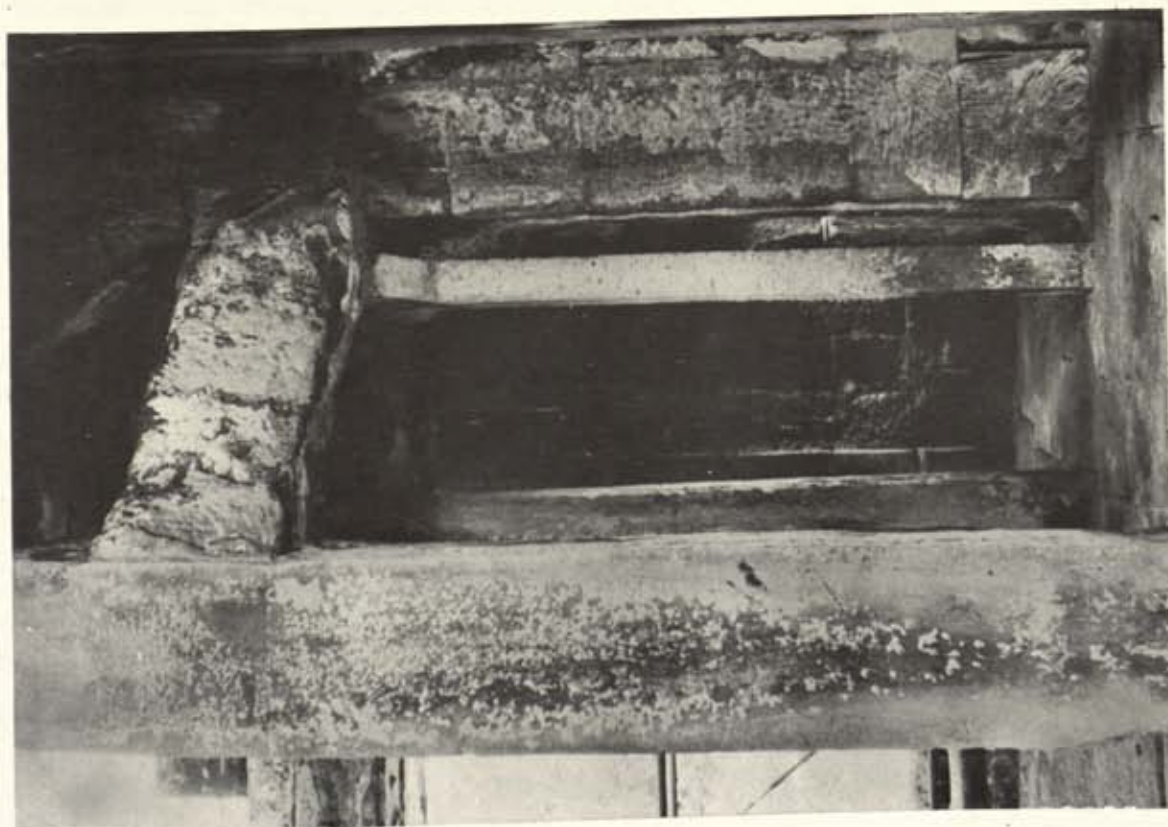
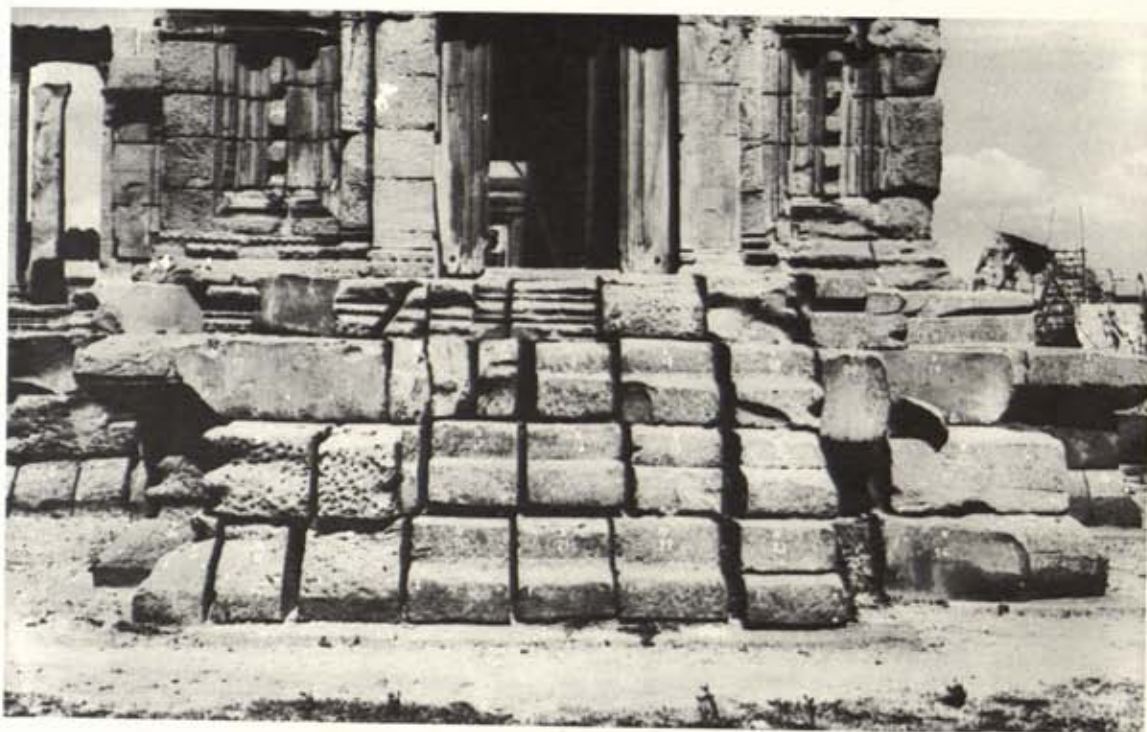
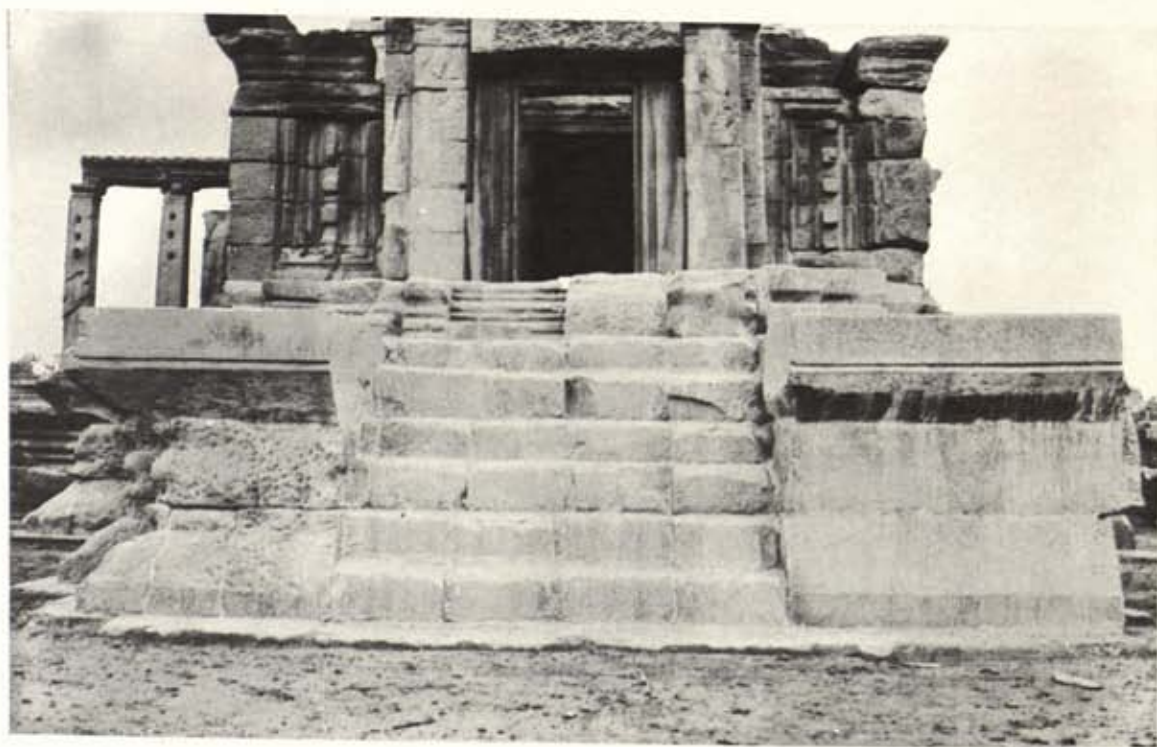
Northern Library : stepped entrance, A, before and B, after conservation

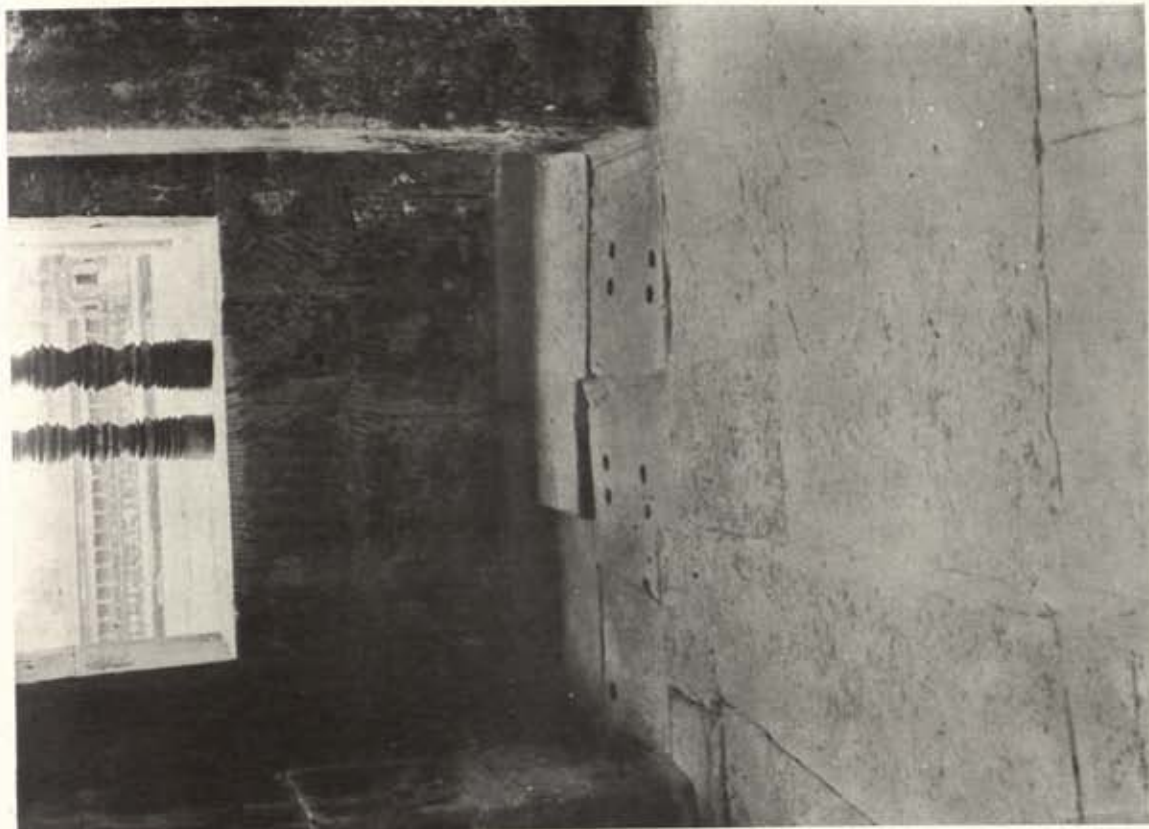
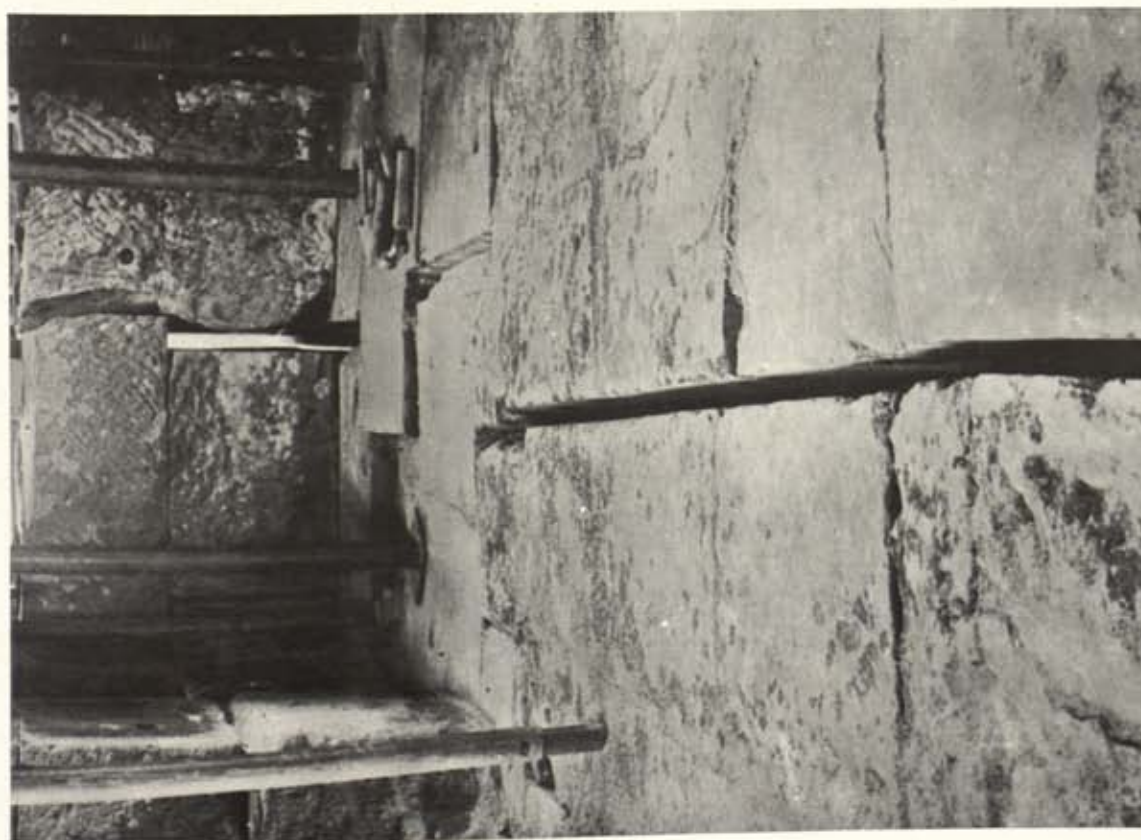
Northern Library : flooring, A, before and B, after conservation

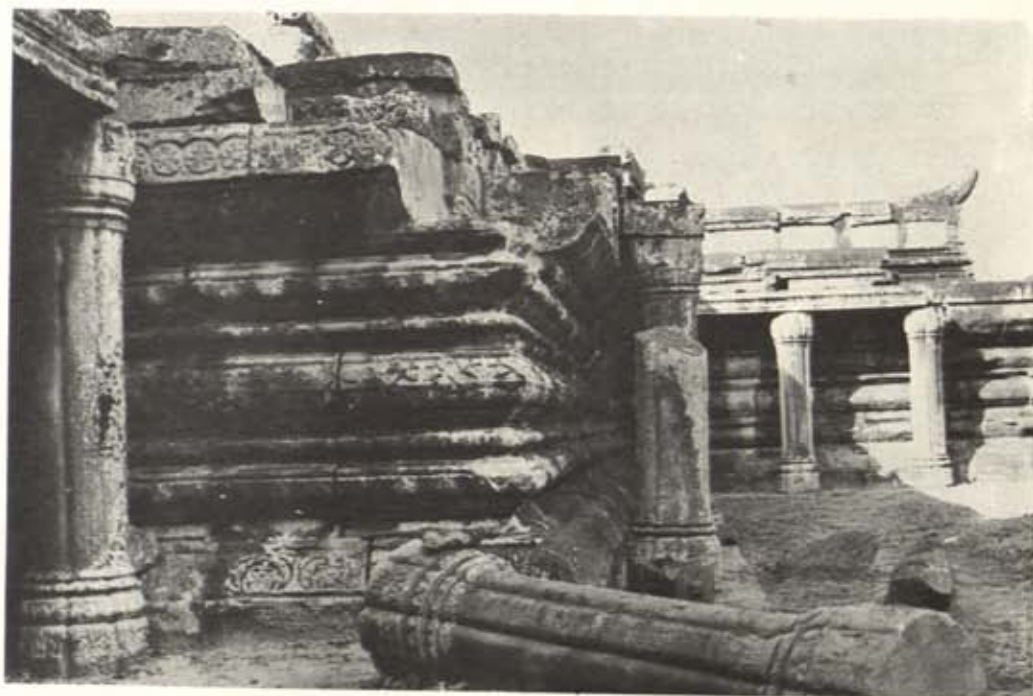
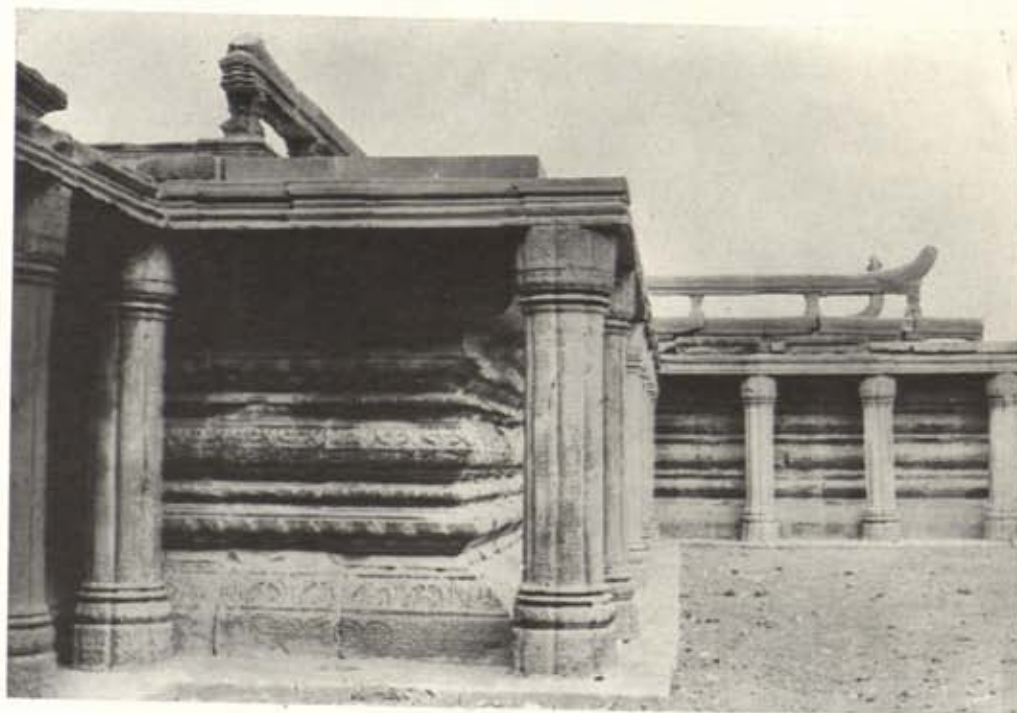
Esplanade (Ranga-Mancha) : north-eastern portion, A, before and B, after conservation

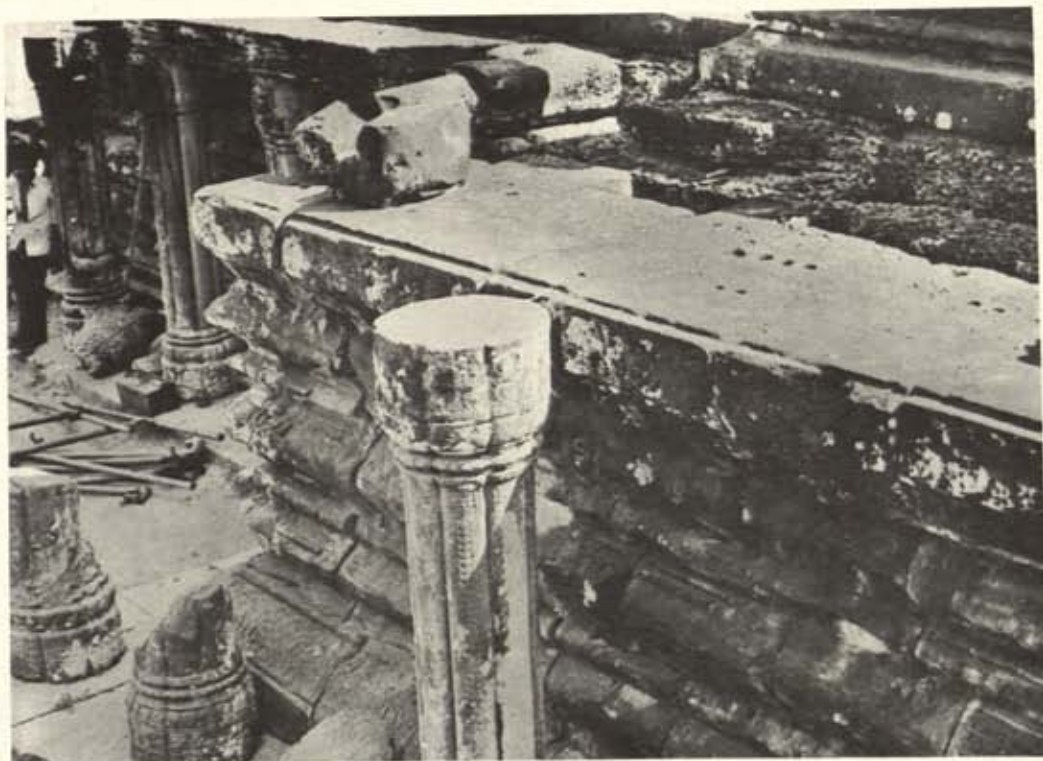
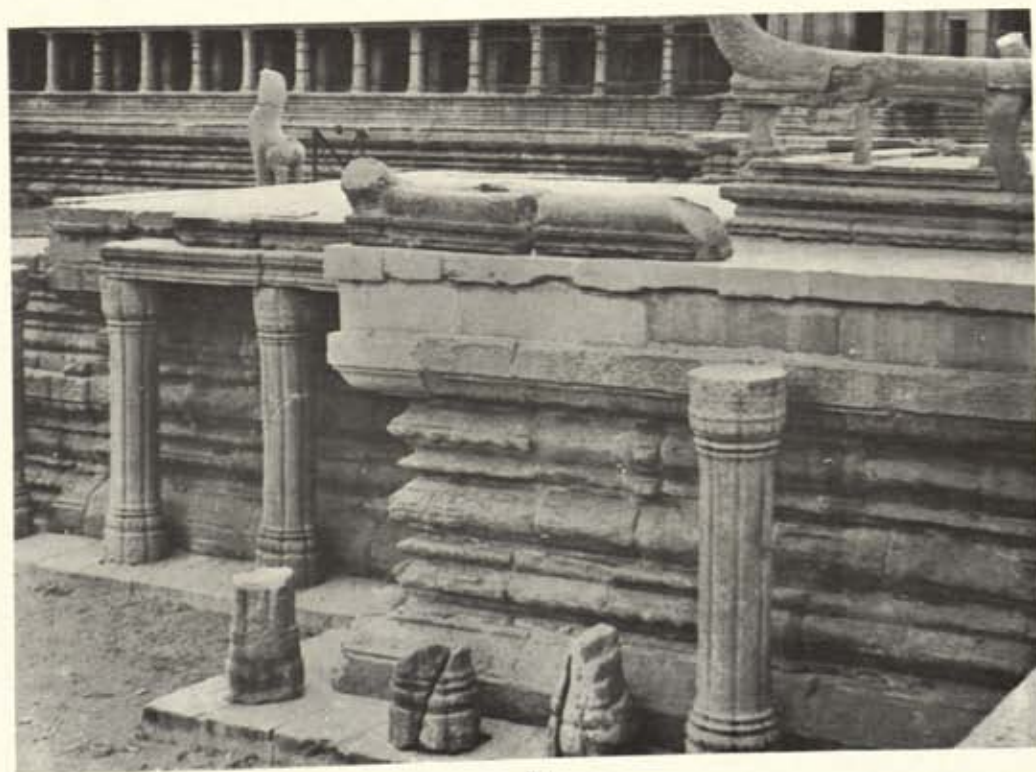
Esplanade (Ranga-Mancha) : north-eastern portion, A, before and B, after conservation

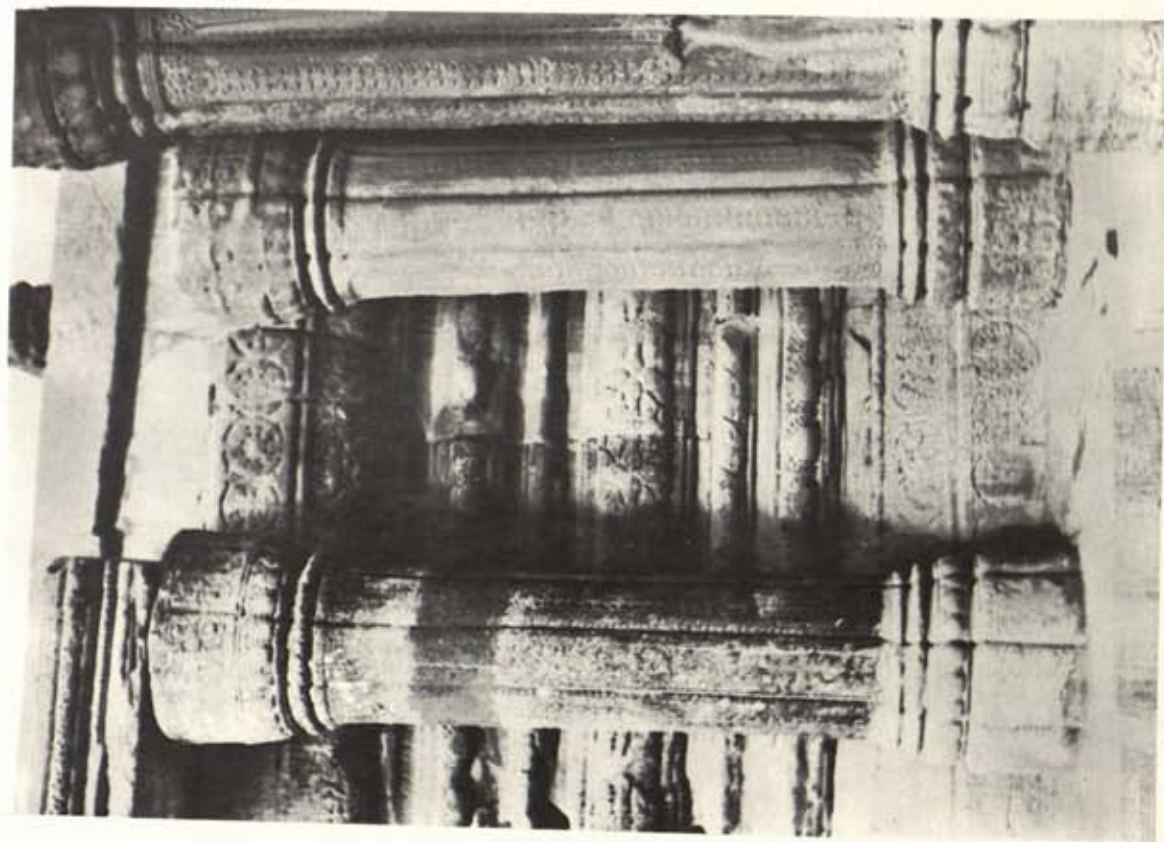
B

Esplanade (Ranga-Mancha) : north-western portion, A, before and B, after conservation

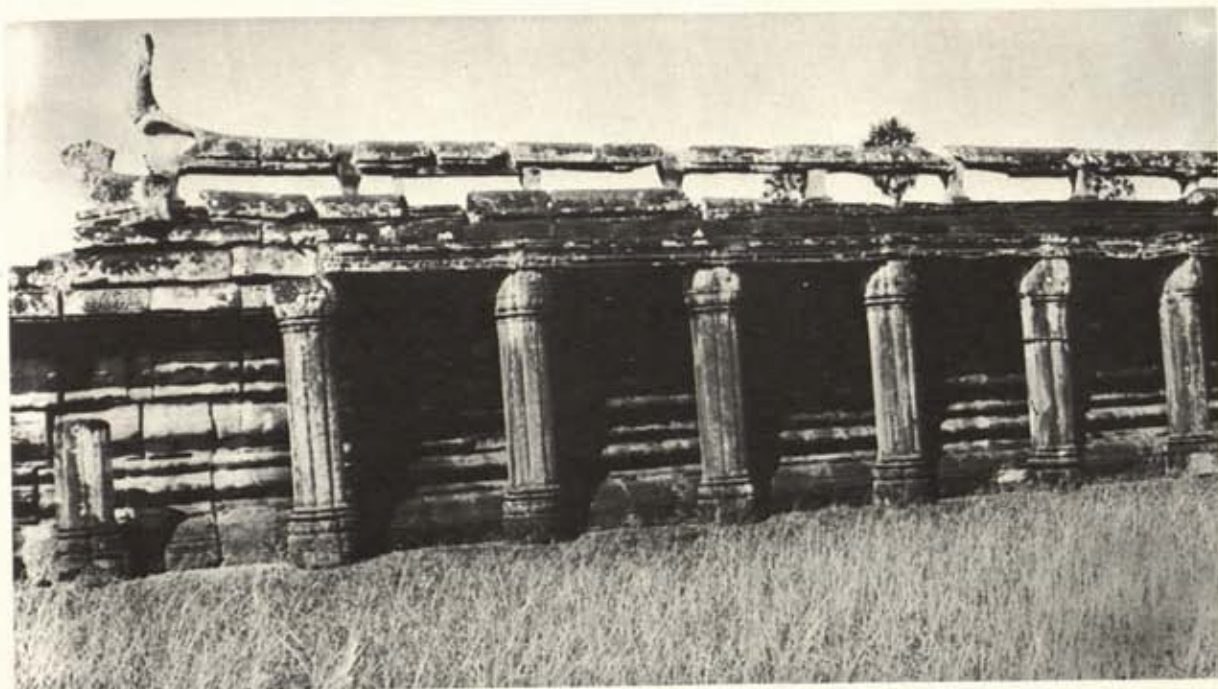
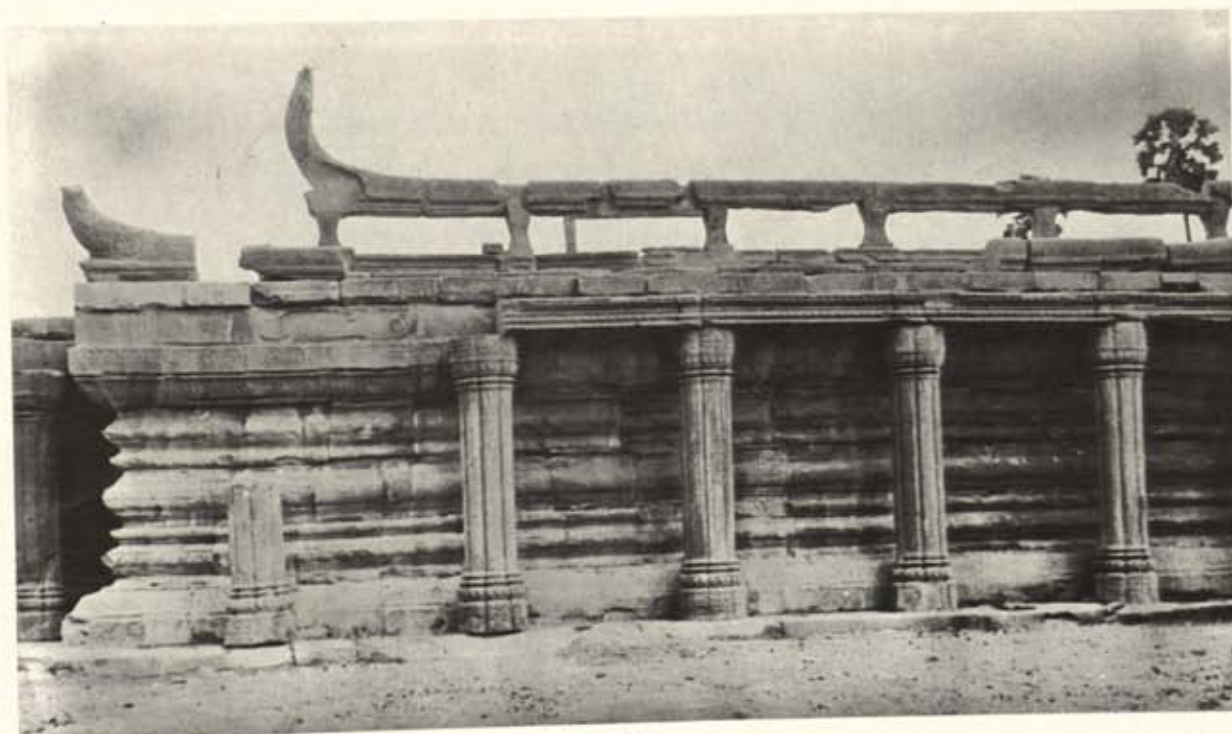
Esplanade (Ranga Mancha) : north-western portion, A, before and B, after conservation

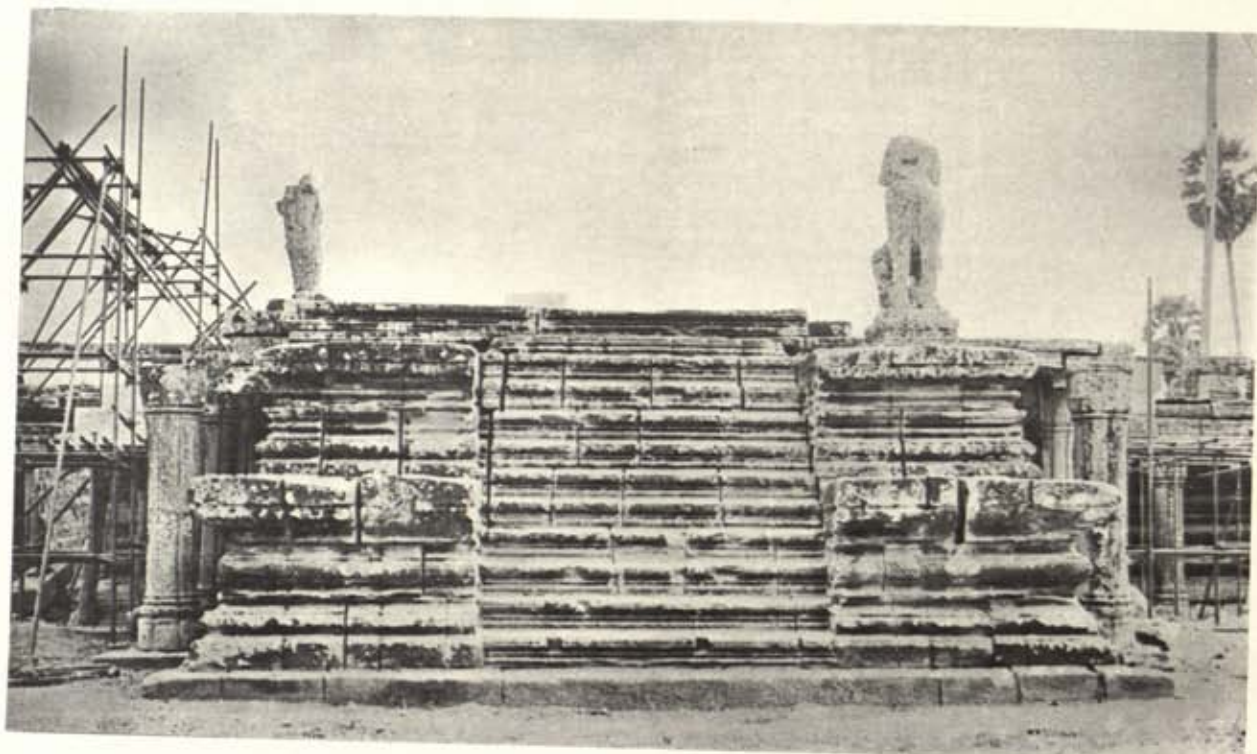
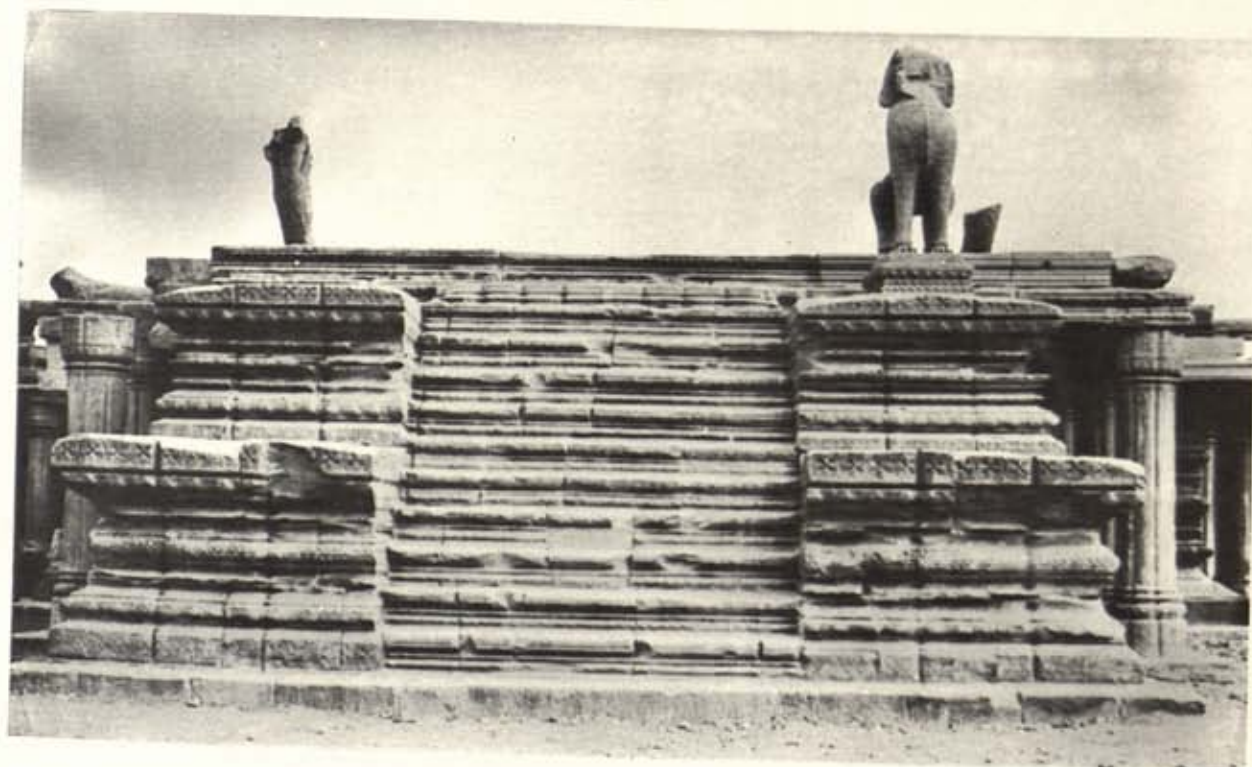
Esplanade (Ranga Mancha) : southern stepped entrance, A, before and B, after conservation

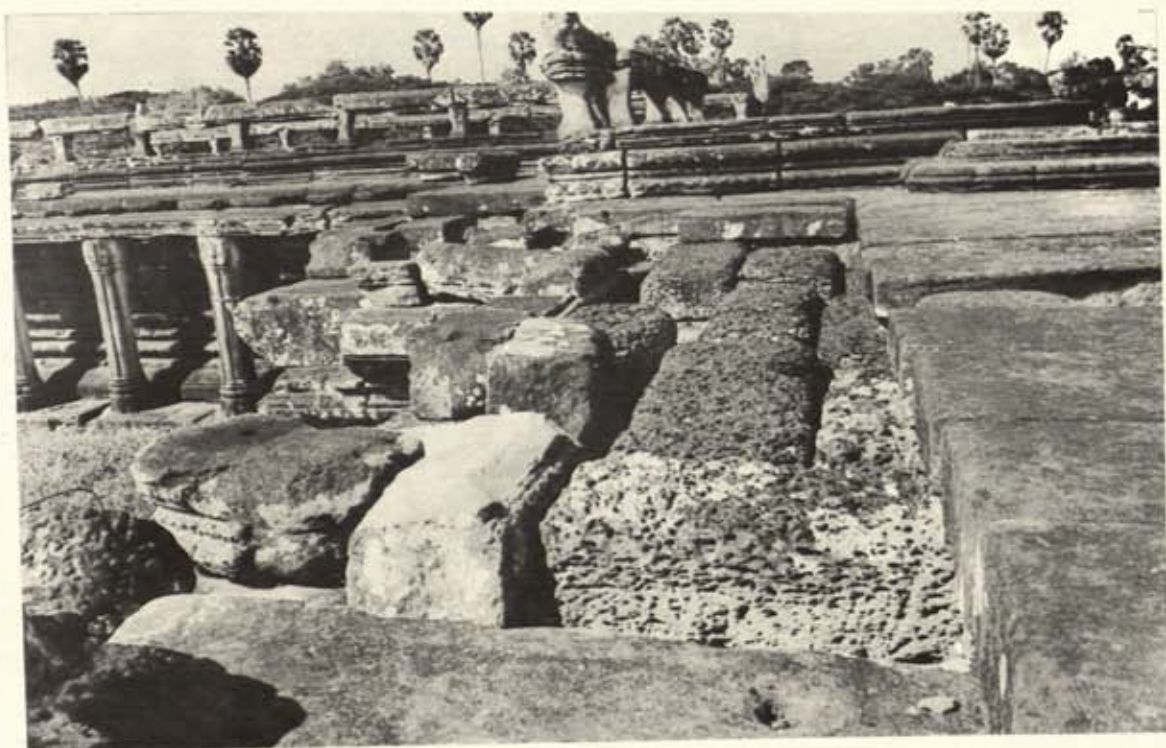
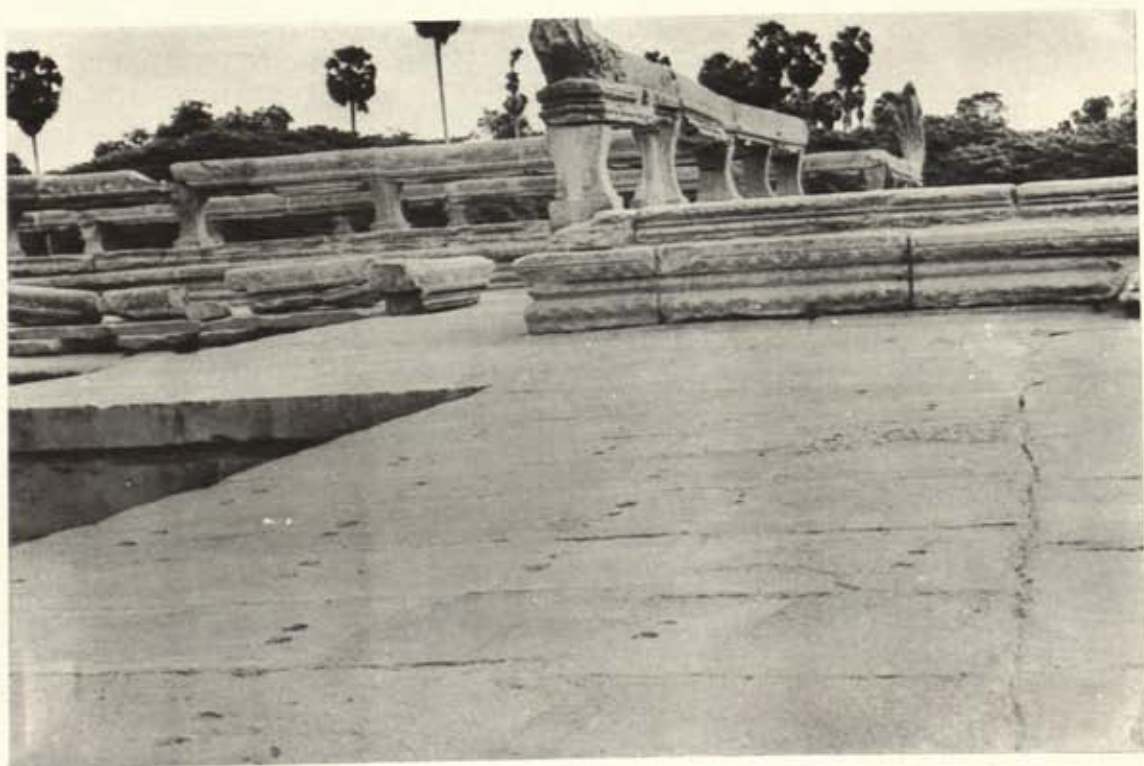
Esplanade (Ranga Mancha) : flooring, A, before and B, after conservation

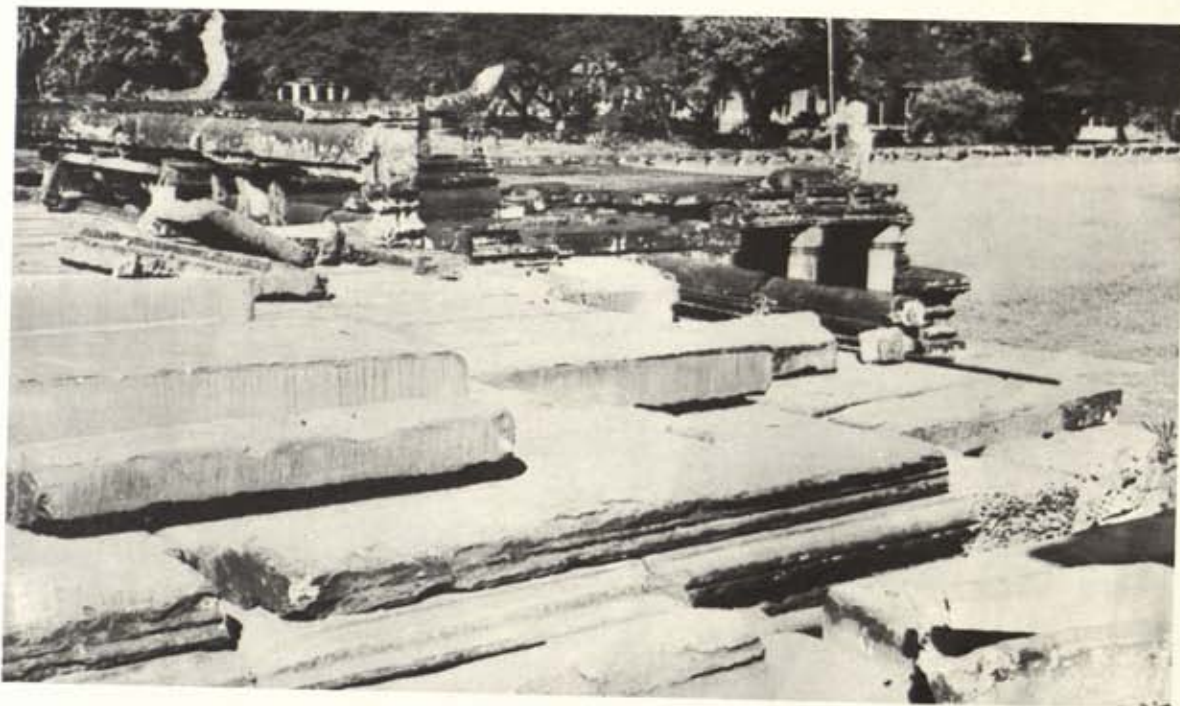
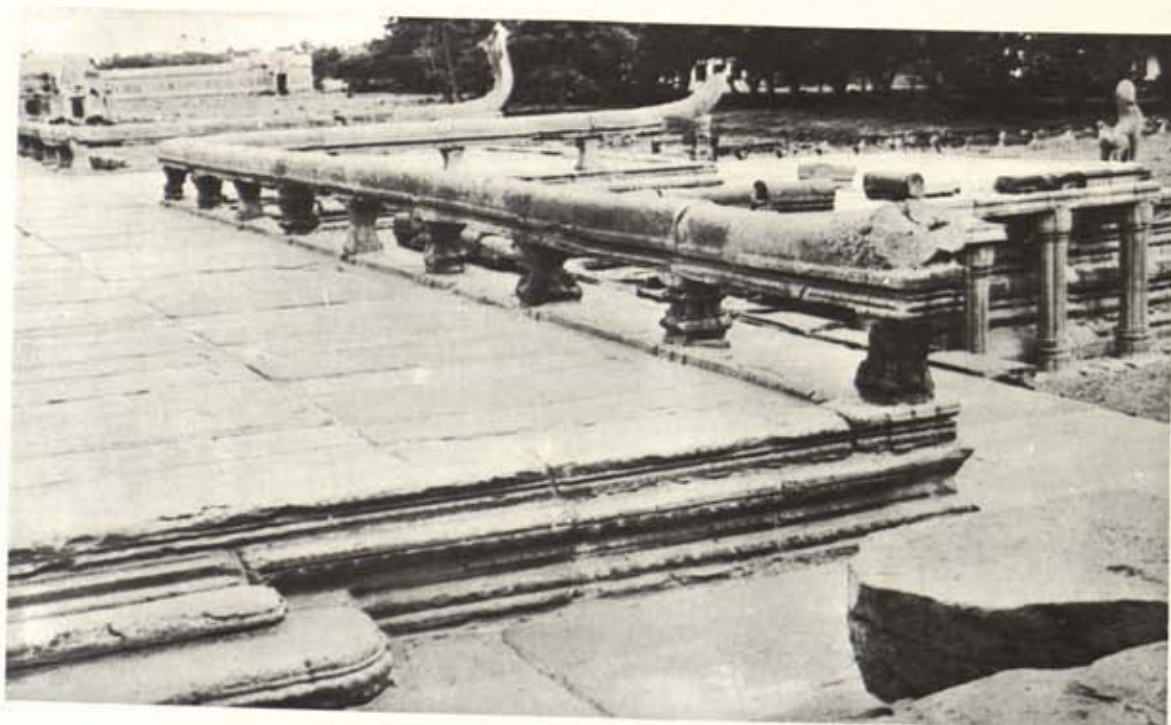
Esplanade (Ranga Mancha) : flooring, A, before and B, after conservation

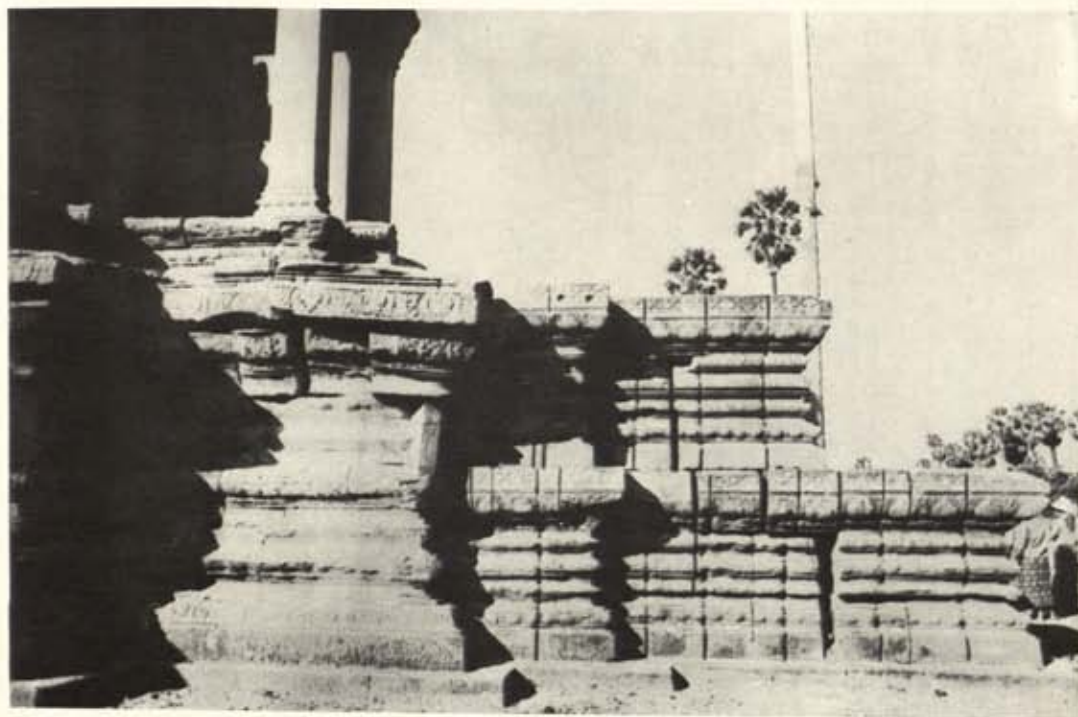
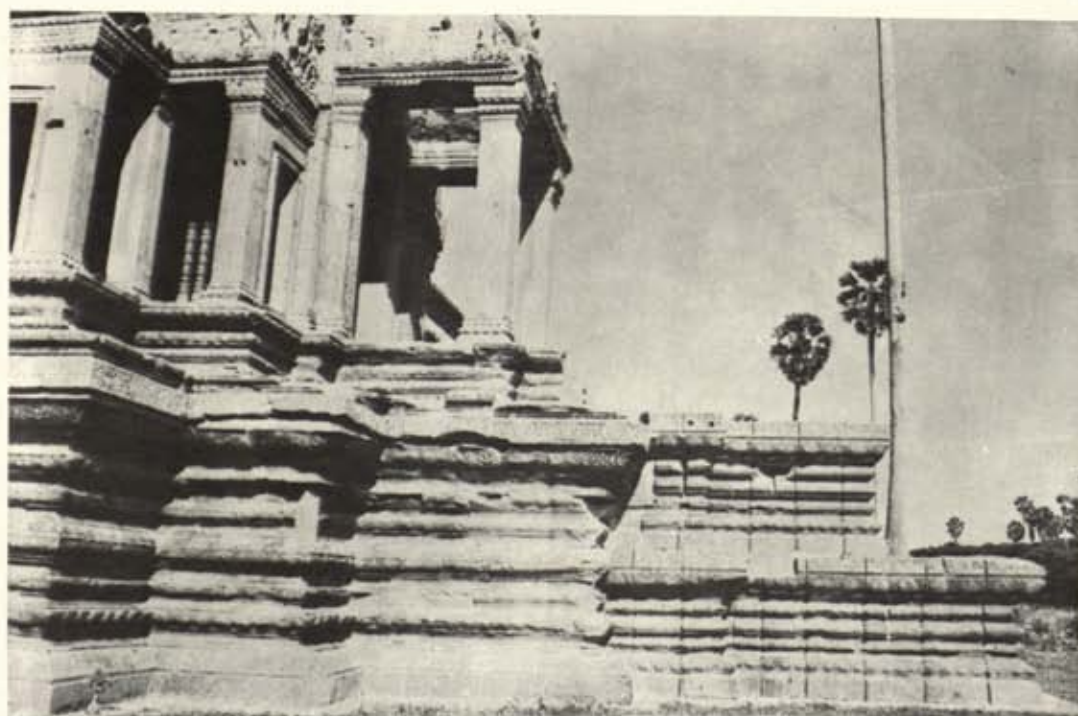
Third Enclosure : northern-central stepped entrance porch, A, before and B, after conservation

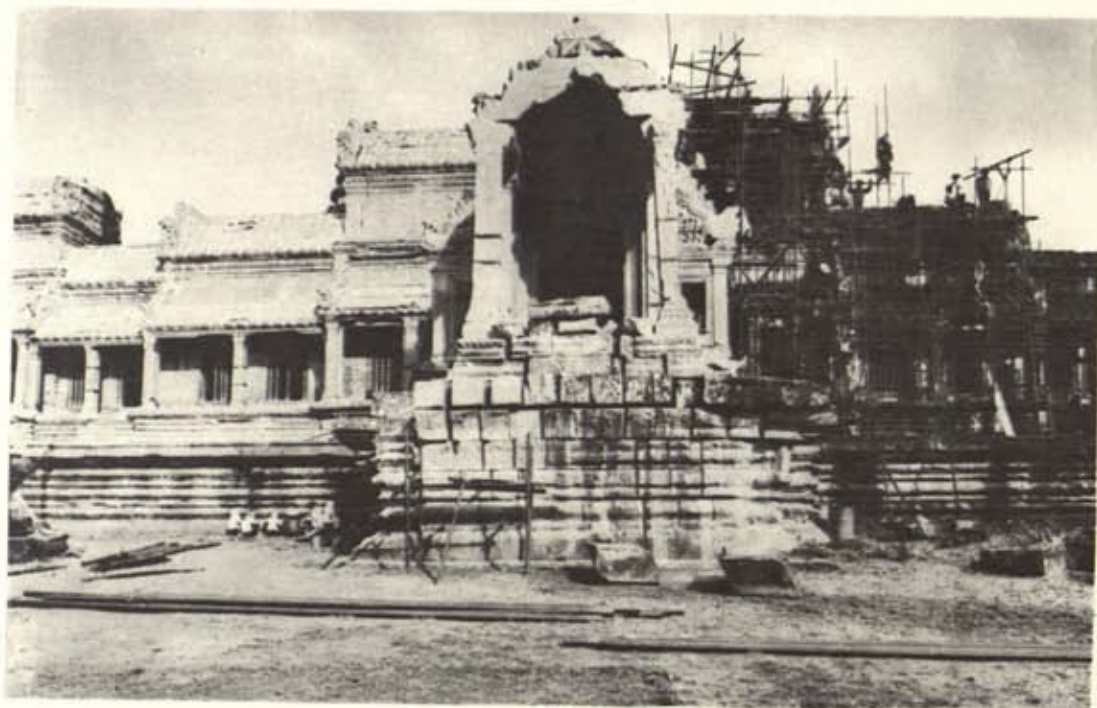
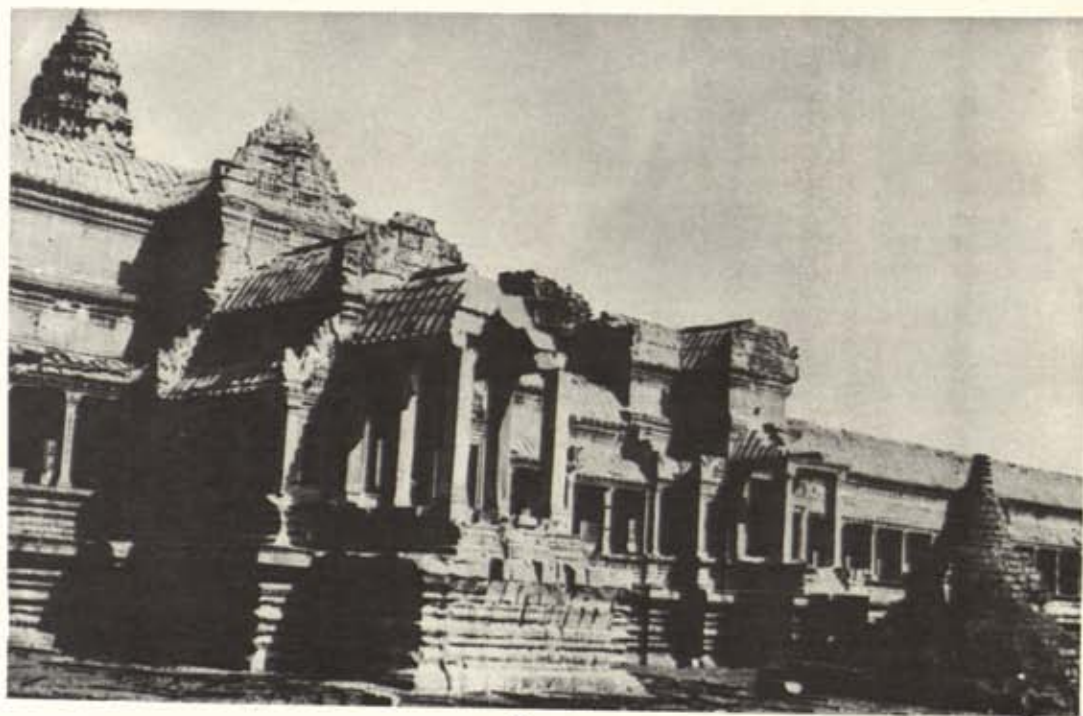
Third Enclosure : eastern-central entrance porch, A, before and B, after conservation

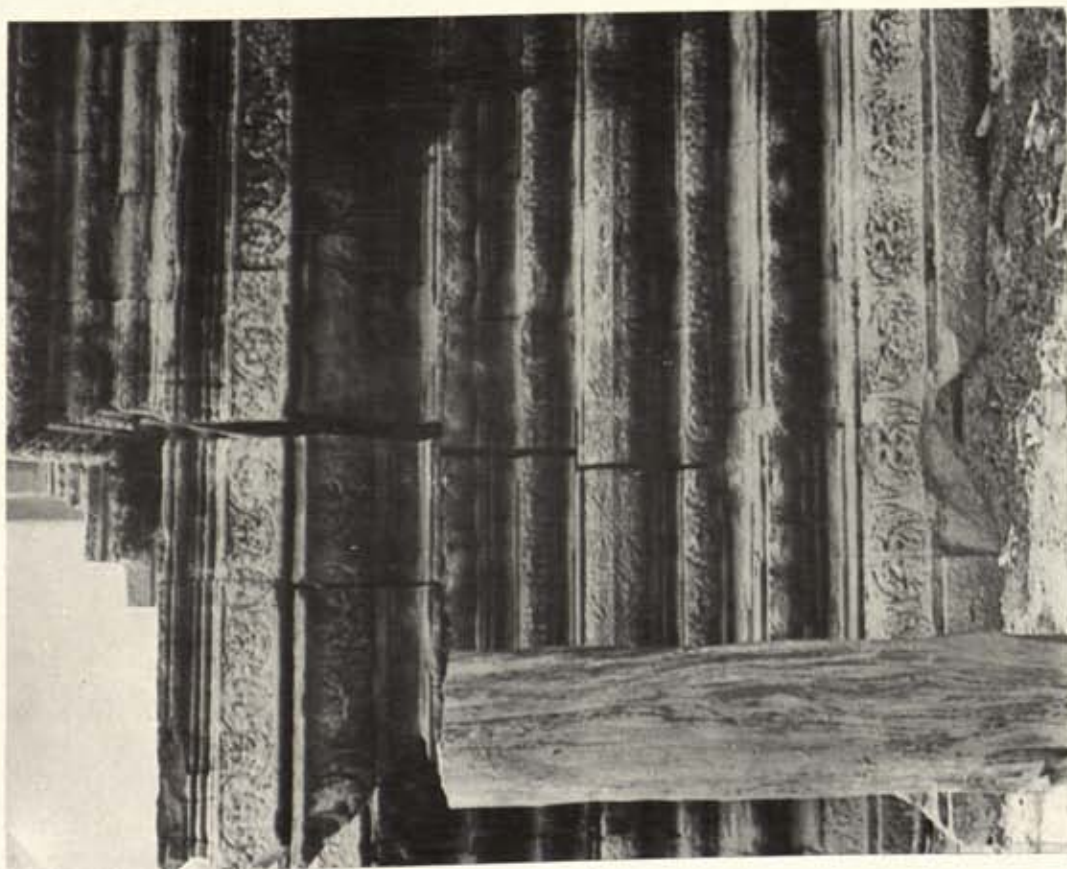
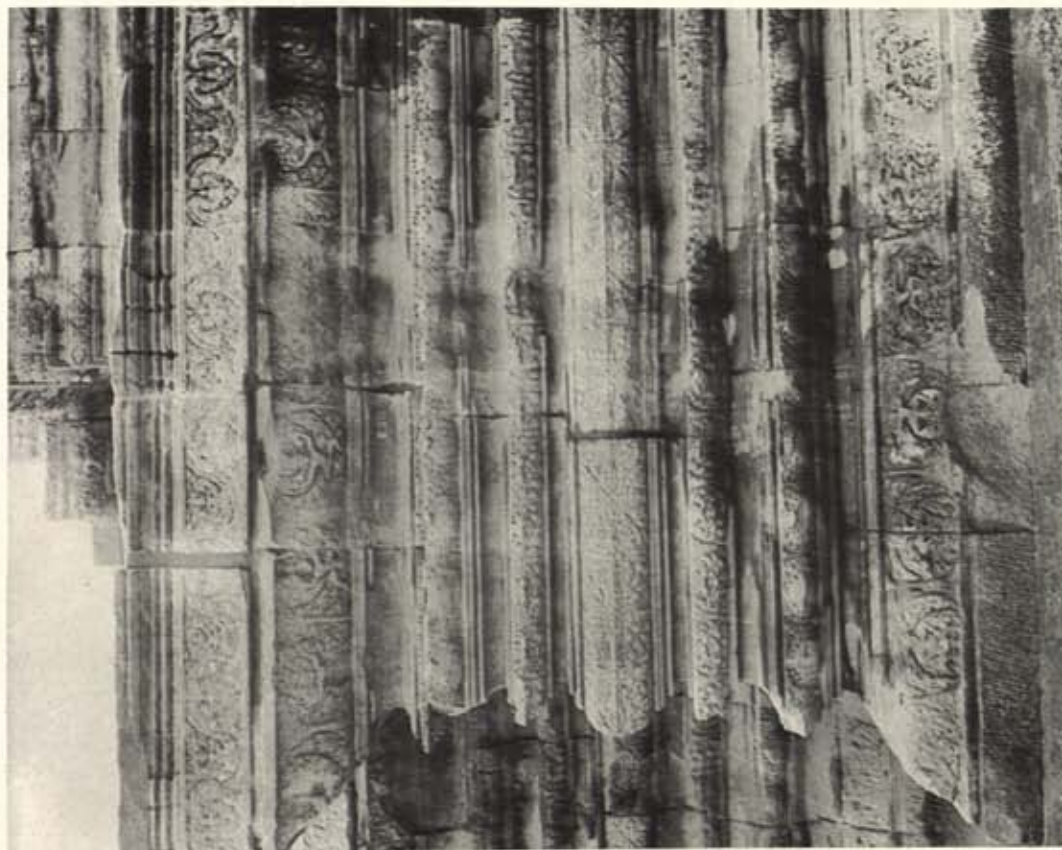
Third Enclosure : eastern-central entrance porch, A, before and B, after conservation
